Manhole Inspection Summary

Manhole # S29K__022MH

Location Address: **behind 300 McHenry**

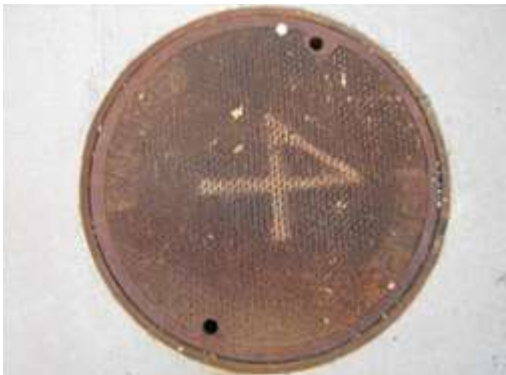
Miscellaneous

cover pic

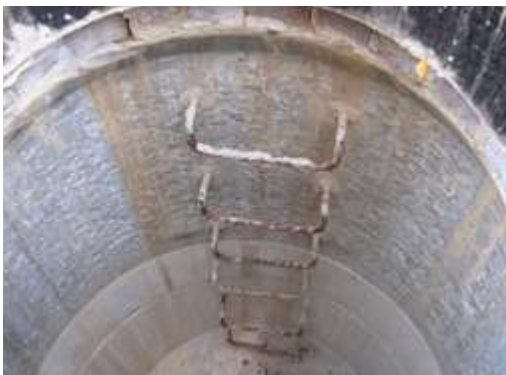
Defect 4

Condition: ☐ Sound ☐ Cracked ☐ Root Intrusion ☒ **Loose Brick** ☒ **Deteriorated**

Infiltration: ☐ None ☒ **Joint** ☐ Cracks ☐ Mortar ☐ Roots ☐ Wall

Steps Count: **6** Missing: **0** ☒ **Corroded**

chimney joint infiltration; corroded steps

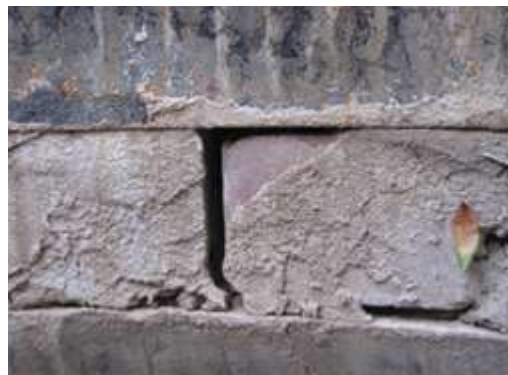
Defect 3

chimney deteriorated & loose brick

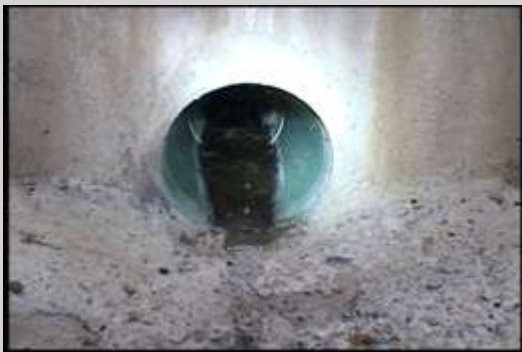
12 O'Clock Outflow

8 in. Circular Gravity Sewer
Pipe Out @ 12 O'Clock

Infiltration: **None** Pipe Seal Cond: **Sound**
